# ***Acclaim Home Inspections, LLC***

## **Property Inspection Report**

1234 Home Road, Hometown, IN 47777  
Inspection prepared for: Henry Homeowner  
Real Estate Agent: None -

Date of Inspection: 6/9/2019 Time: 9:00 AM  
Age of Home: built in 1999 Size: 2400 sq.ft.  
Weather: Sunny & hot 80s

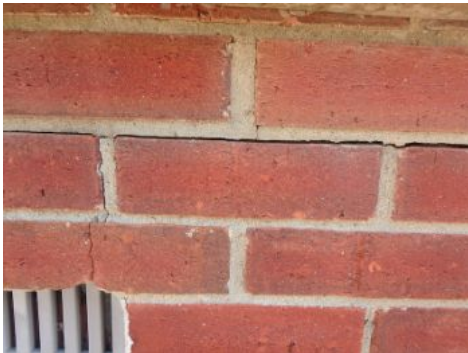
- Monitor/Maintenance: Concrete on front slab & brickwork is showing some cracking/past settling. Sealing these area will slow the further deterioration of the concrete. Monitor over time for change.

Some settling noted at front porch

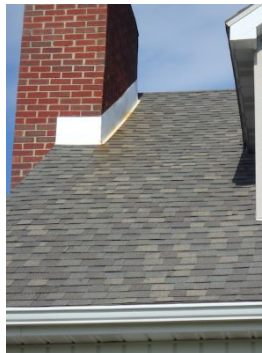
Roof Chimney

• Repair needed: Chimney crown shows rust/wear. Suggest painting/sealing to reduce deterioration.

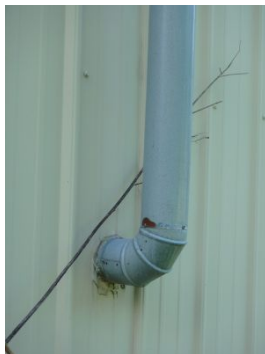
- Note: **HVAC** system in barn appears abandoned. If you plan to use this unit we recommend review by a licensed HVAC tech for proper connection/installation.
- Appeared functional at time of inspection.
- Personal items in barn block complete inspection of all floor, wall and ceiling areas.
- Note/Limitation: Bathroom in barn was inoperable during inspection. No testing of fixtures was completed as part of this inspection.

Abandoned HVAC unit vent

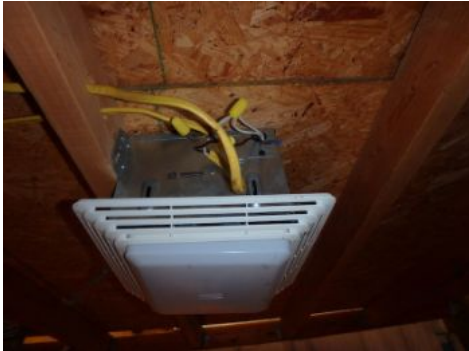
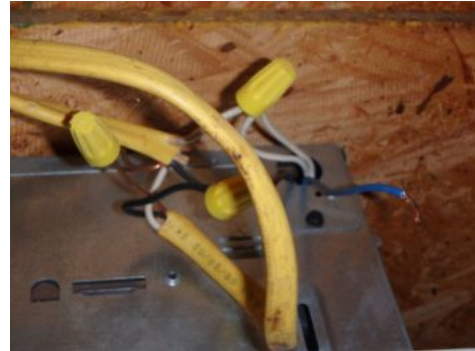
- **Safety Item:** Several outlets along west wall show open grounds. Suggest electrician review & repair.
- **Safety Update:** No GFCI protection noted in barn. Suggest installing GFCI protection at any area where water may be present.
- **Safety Item:** Exposed connections at bath light/fan fixture. Suggest electrician repair.

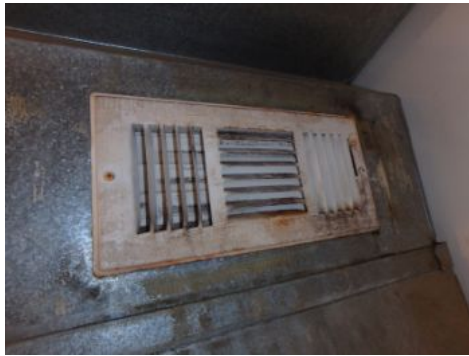
- **Safety Item:** Supply vent in ductwork located inside garage area. This is not recommended & can be a safety concern. Suggest contractor permanently seal off.

Vent into garage

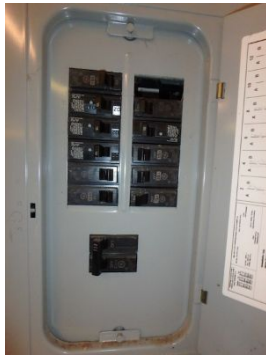
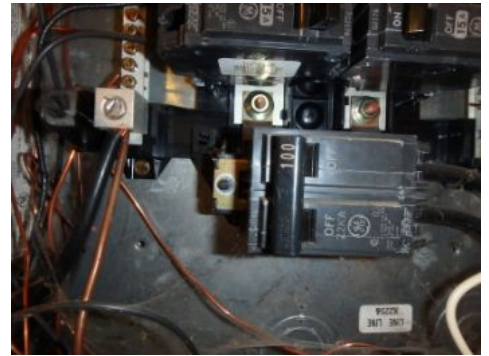
- No major system safety or function concerns noted at time of inspection at main panel box.
- Review/Repair: Unable to determine if pole barn panel is be fed directly from utility meter. Suggest electrician verify & if not track the source & review/repair grounding/feed appropriately.
- Safety Item: Missing knockouts at the barn panel cover. Suggest installing covers/caps to prevent accidental shock.

Barn panel

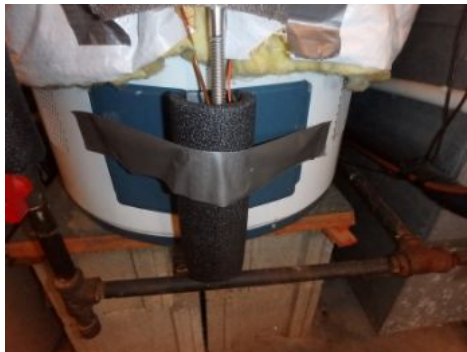
- The combustion chamber appears to be in functional condition, limited view due to design and access.

Blocked access to combustion chamber

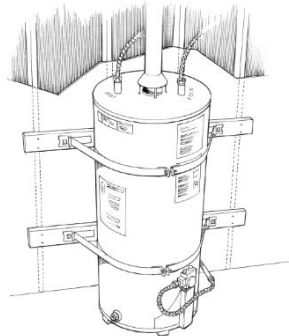
- Tank appears to be in functional condition -- 2010 model noted.
- Limitation: Water treatment system was not evaluated as part of this inspection.
- Safety Update: Seismic straps may not have been required at time of construction but would be an important safety update to meet current standards. Be sure these are installed when unit is replaced.

Example of seismic straps

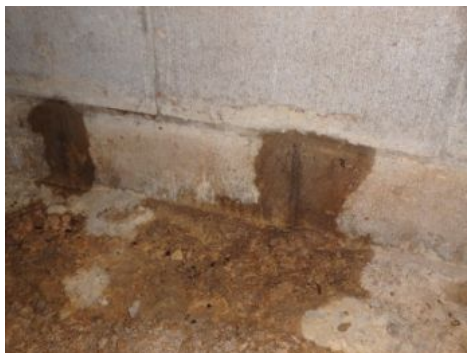
- Maintenance: Evidence of some moisture/water penetration observed near driveway on south side. Suggest sealing exterior gap between slab & home to reduce water entry.
- **Repair needed: Block at gas line entry is broken & out of place. Suggest contractor reseal & mortar in place.**

Some moisture noted

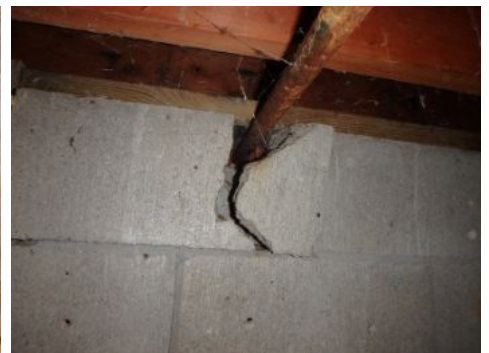
Damaged/loose block at gas line

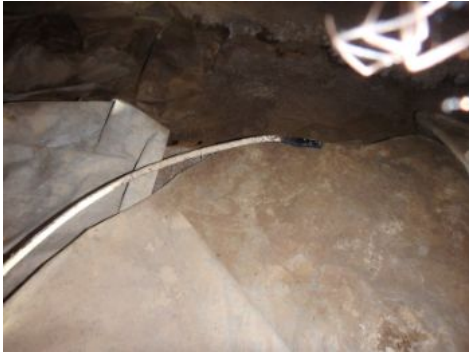
- **Safety Item:** Loose circuit noted at south east corner of crawlspace. Suggest either complete installation or terminate in a covered junction box.

Loose circuit in SE corner

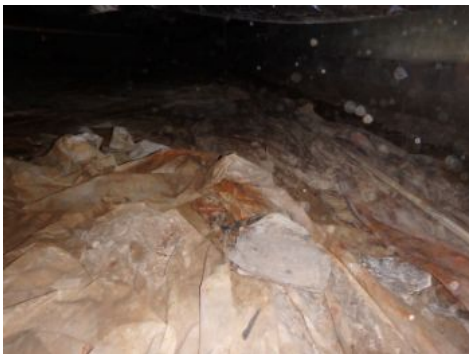
- **Repair needed:** Deteriorated & misplaced vapor barrier throughout crawlspace. Suggest replacing vapor barrier to better control moisture under home.

Vapor barrier deteriorated/displaced

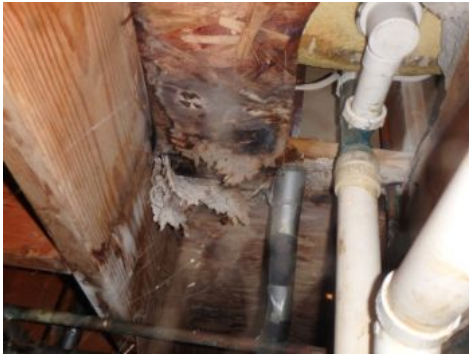
Observations:  
• **Repair needed:** Signs of moisture damage at subfloor under master tub. Some moisture noted. Suggest contractor review source of moisture & repair/support subfloor as needed.

Damaged area under master tub

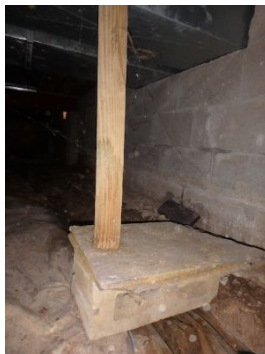
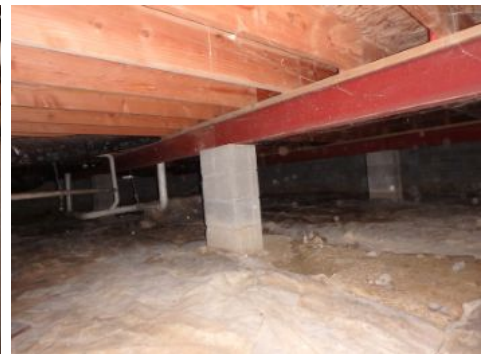
Observations:  
• Steel beams & concrete block columns noted in functional condition.  
• **Repair needed:** Added supports/brace noted under dining area at southwest area of crawlspace not secured or well supported. Suggest contractor review & properly install support & brace.

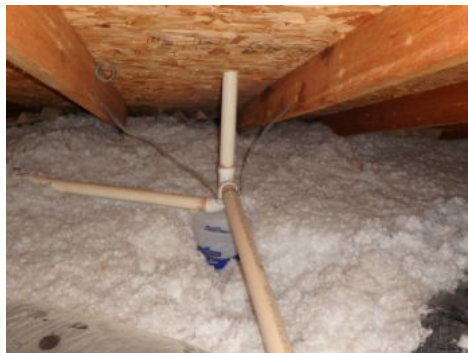
Observations:  
• PVC plumbing vent pipe appeared functional, at time of inspection.  
• Evidence of past leaks present. Dry at time of inspection.

Evidence of past leaks noted

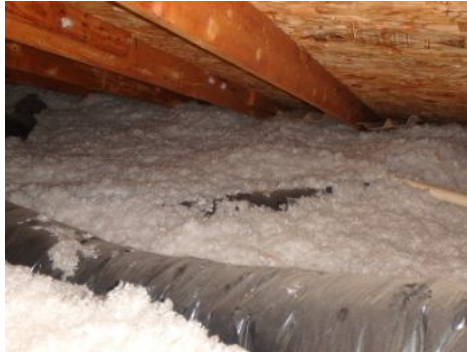
Attic Insulation Condition

- Some areas have insulation misplaced. Suggest having entire space/insulation spread evenly for best efficiency.

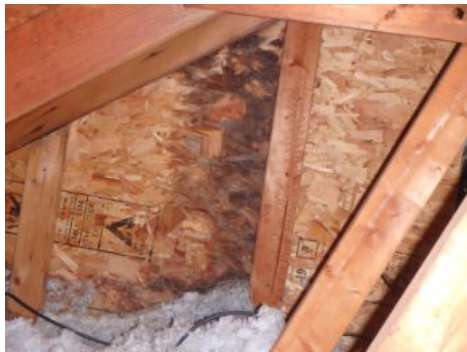
- Limitation: No accessible inside attic space.
- Evidence of past leaks beside chimney. Appeared dry at the time of inspection.

Evidence of past leaks near chimney

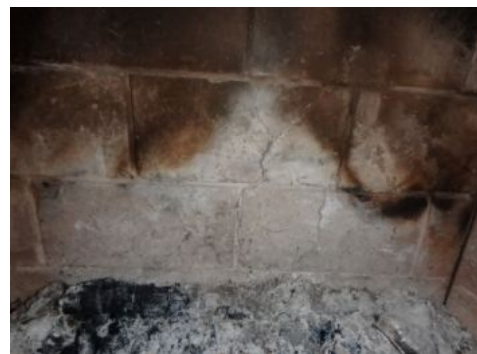
Interior Areas		
Page 32 Item: 11	Fireplace	• Repair/Safety item: Refractory panel cracked at rear of firebox & some creosote buildup noted. Also, non-combustible hearth extension extending 16" in front of firebox is missing. Suggest chimney specialist repair & clean as needed.

- Damper was opened and closed several times.
- **Repair/Safety item: Refractory panel cracked at rear of firebox & some creosote buildup noted. Also, non-combustible hearth extension extending 16" in front of firebox is missing. Suggest chimney specialist repair & clean as needed.**

Some cracks noted at refractory panel
