# ***Acclaim Home Inspections, LLC***

## **Property Inspection Report**

1234 Home Road, Hometown, IN 47777  
Inspection prepared for: Henry Homeowner  
Real Estate Agent: None -

Date of Inspection: 6/9/2019 Time: 9:00 AM  
Age of Home: built in 1999 Size: 2400 sq.ft.  
Weather: Sunny & hot 80s

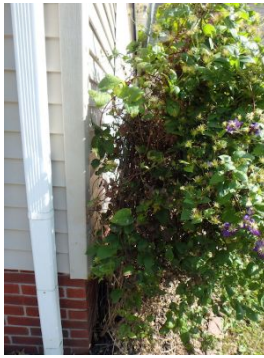
• Maintenance: Prune or remove any plants that are in contact or proximity to home to eliminate pathways of wood destroying insects.

Grounds Vegetation Observations

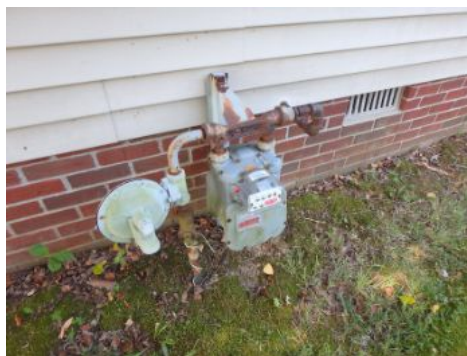
Main gas shut off at meter - North side

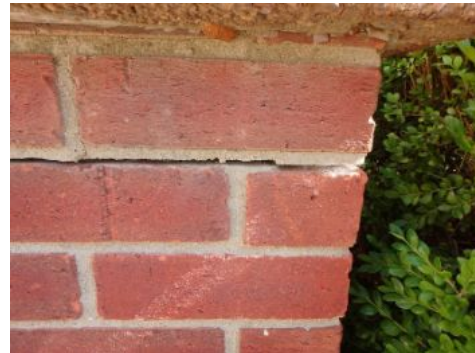
Grounds Landing

- Monitor/Maintenance: Concrete on front slab & brickwork is showing some cracking/past settling. Sealing these area will slow the further deterioration of the concrete. Monitor over time for change.

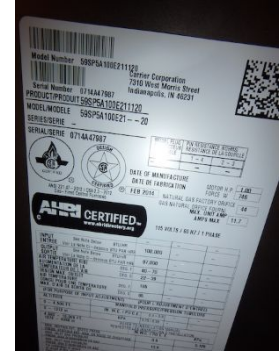
2014 model

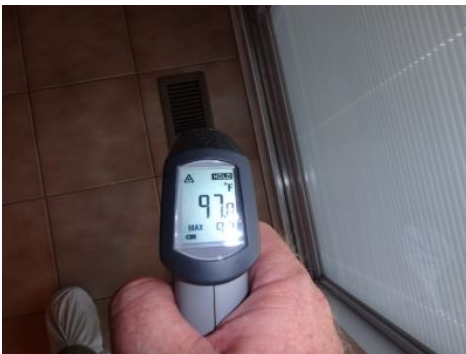
Supply vent heat temp main floor (short run)

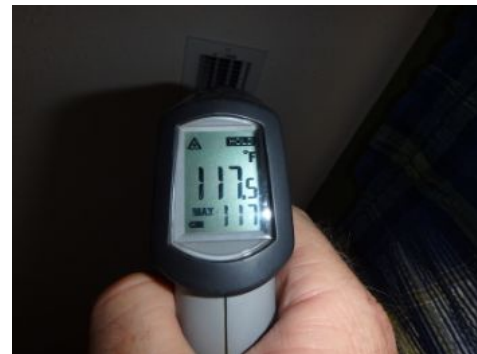
Supply vent heat temp upstairs

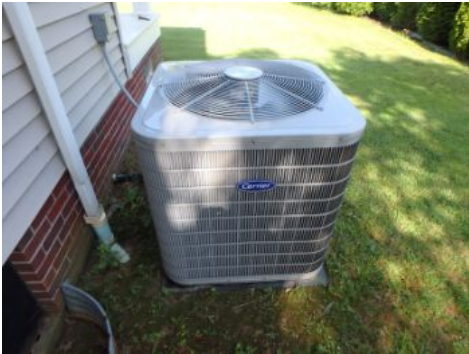
2014 model

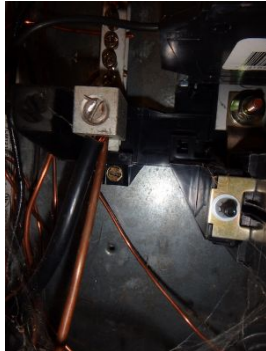
- No major system safety or function concerns noted at time of inspection at main panel box.
- Review/Repair: Unable to determine if pole barn panel is be fed directly from utility meter. Suggest electrician verify & if not track the source & review/repair grounding/feed appropriately.
- Safety Item: Missing knockouts at the barn panel cover. Suggest installing covers/caps to prevent accidental shock.

Have electrician review grounding/feeds

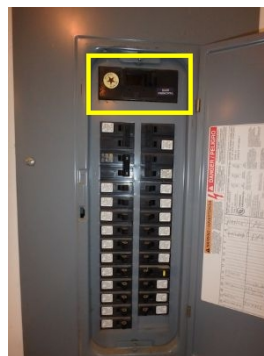
Disconnect in top of panel

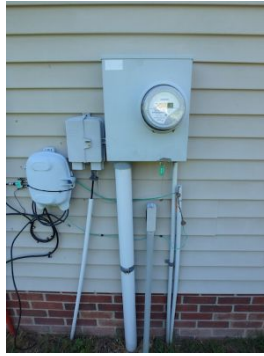
There is an underground service lateral

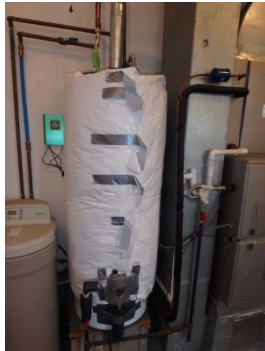
2010 model

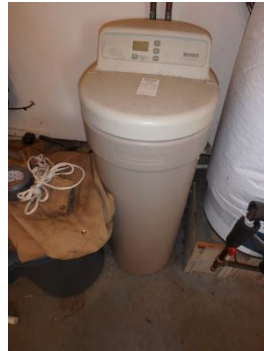
Water treatment system not tested

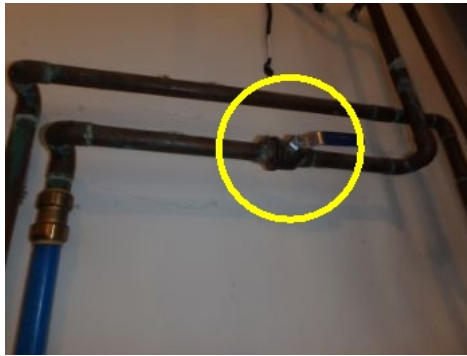
Main shut off above unit

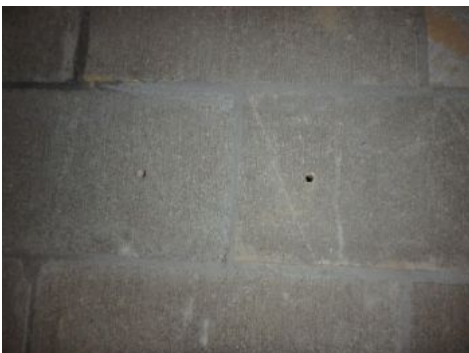
Drill marks from previous termite treatment

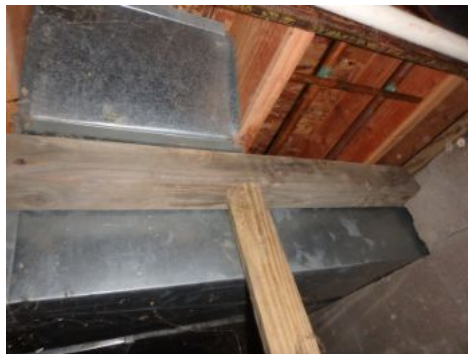
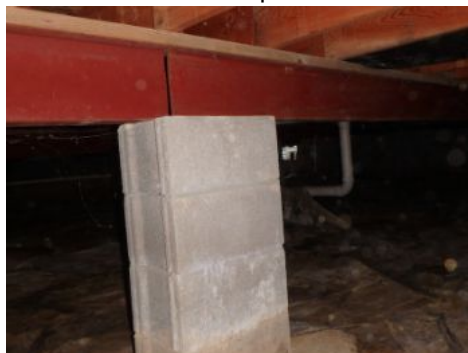
Observations:  
• Steel beams & concrete block columns noted in functional condition.  
• **Repair needed:** Added supports/brace noted under dining area at southwest area of crawlspace not secured or well supported. Suggest contractor review & properly install support & brace.

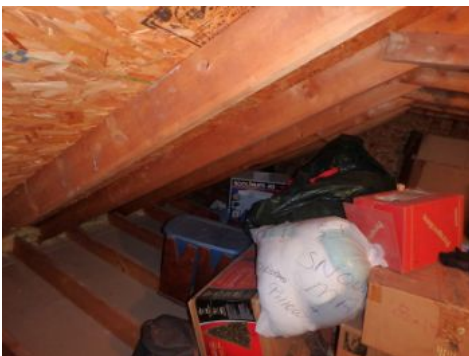
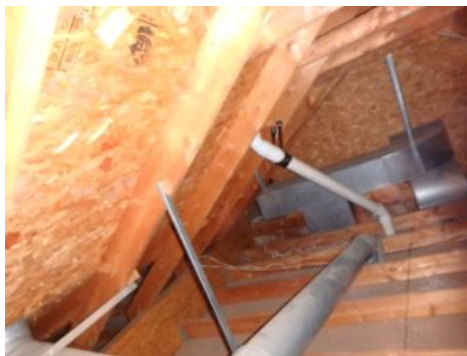
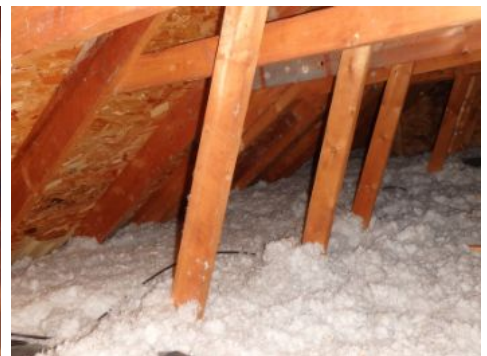
- Evidence of past leaks noted, dry at time of the inspection.

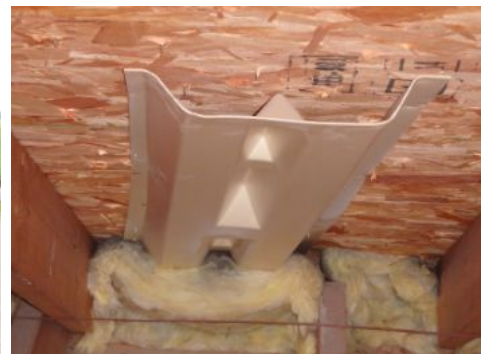
Soffit baffles noted

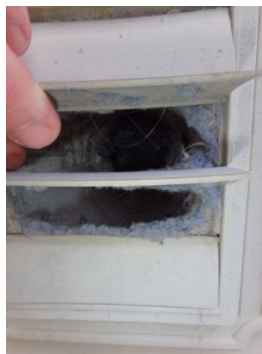
Laundry Dryer Vent

- The dryer vent has lint build up at the exterior cover. Clean as needed.

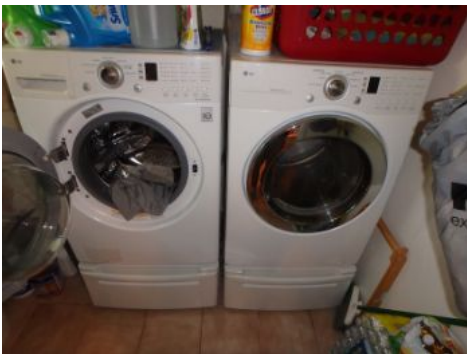
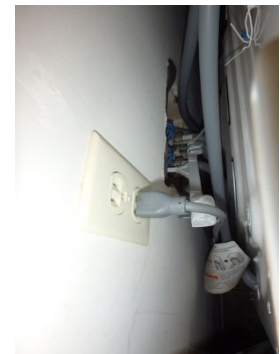
Laundry Plumbing

- Limitation: Units were not installed/tested as part of this inspection. If further review is desired suggest requesting information from sellers.

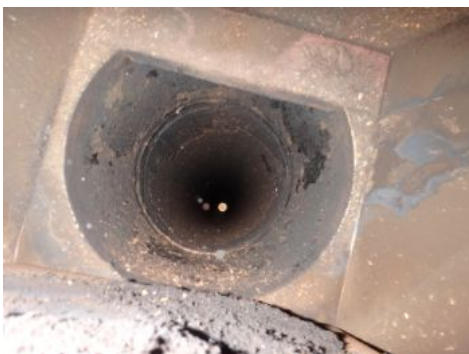
Interior Areas Fireplace

- Damper was opened and closed several times.
- **Repair/Safety item: Refractory panel cracked at rear of firebox & some creosote buildup noted. Also, non-combustible hearth extension extending 16" in front of firebox is missing. Suggest chimney specialist repair & clean as needed.**
